OMAE2007-29751

**BARGE-ASSISTED DRAFT REDUCTION OF SEMI-SUBMERSIBLE DRILLING UNIT  
GSF DEVELOPMENT DRILLER I  
FOR TOW-OUT FROM INGLESIDE TO OFFSHORE GULF OF MEXICO**

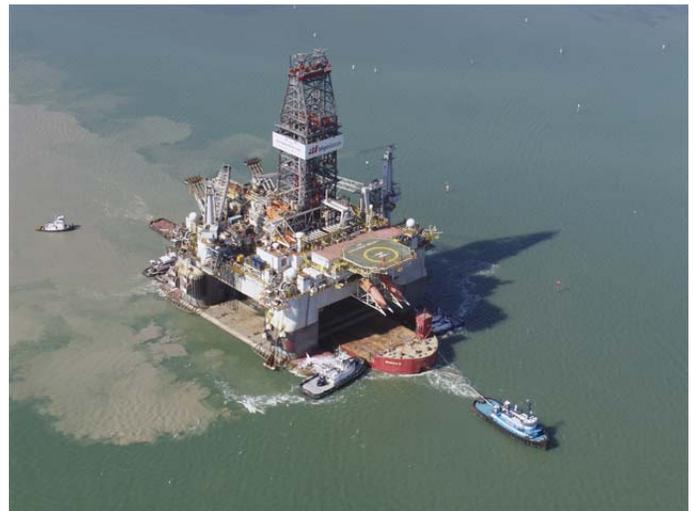
Figure 1. Tow-out of the *GSF Development Driller I* with a lift from *Boabarge 16*.

blocks were mounted to the barge hull, in line with new strong stiffeners inside the rig's cross braces. The created bottom clearance of 1.0 m (3.3 ft) allowed for the DP thrusters to remain in place while the rig with barge was safely towed through the channels, see figure 1. For maneuvering through the 17 nmiles long narrow channels, an advanced real-time navigation system that incorporated 3-D imagery of the channels was used. Once deeper water was reached offshore, the barge was ballasted and pulled free from the rig. While this barge removal operation appears fairly straightforward, the fact that it was performed offshore in open waters provided the tow-out team with a number of technical and operational challenges.

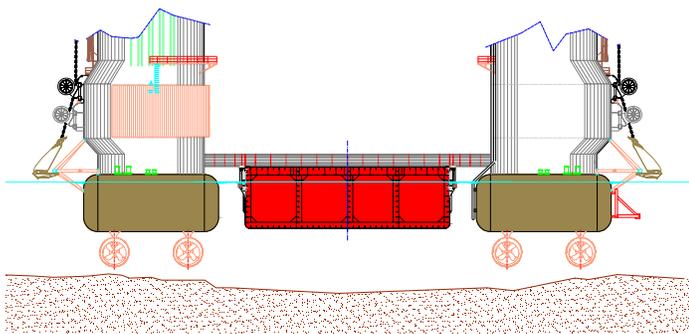
Figure 2. Barge placed between pontoons to lift rig.

- 4.Lift the rig with a single large cargo barge placed under the braces in between the pontoons.

After weighing all the various advantages and disadvantages of the available options, the last option was selected, see figure 2.

The small freeboard and large top corner radius made it difficult to push against the rig pontoons (see also figure 2). The anchor racks on all four corners and a submersed cursor support structure on the starboard outside provided further

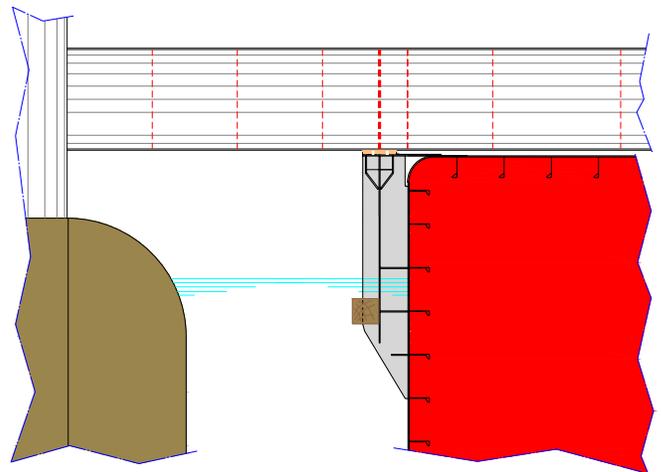
Figure 3. Support bracket concept – total 8 required.

The locations of the four rig braces did not coincide with the locations of the barge frames. Any internal reinforcement of the barge was to be avoided. Therefore, external support brackets were designed to guide the vertical lift loads directly into the barge side shells, see figure 3. The transverse location of the reinforced rig brace diaphragms was such that the moment on each of the brackets was relatively small (because of existing ring stiffeners, the new diaphragms could not be mounted any closer to the side shell). A 3-D FE model of part of the barge hull with a bracket was made to verify the stress levels in the bracket and the hull plating, see figure 4. Based on a design lift load of 500 t per bracket plus hydrostatic pressure on the shell plates, the maximum stresses in the barge hull were found to be between 33% of yield (shell plating) and 43% of yield (shell longitudinals). In the support bracket the maximum stresses were found to be up to 54% of yield. These maximum static stress levels left sufficient margin for additional dynamic stresses.

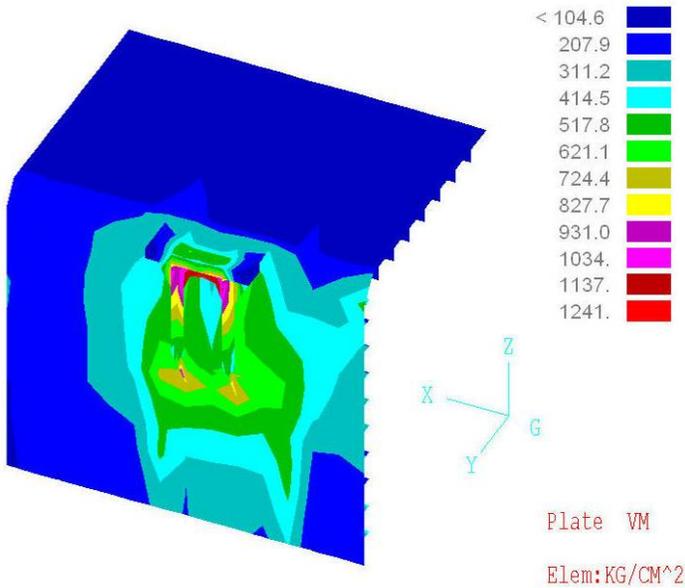
Figure 4. FE model of support bracket on barge hull.

Upon completion of the FE analysis, detailed fabrication drawings of the support brackets were made. All eight brackets were identical, simplifying the prefabrication and installation process.

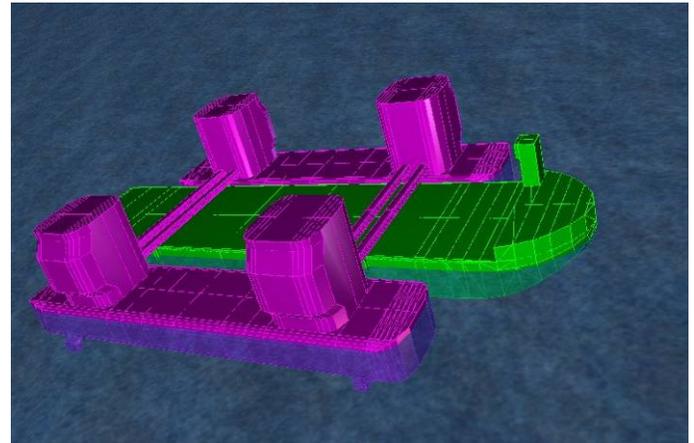
Figure 5. MOSES model of rig and barge combined.

The selected barge matched the rig well. The waterplane area of the barge hull was nearly identical of that of the two rig pontoons combined, giving both units similar heave responses. To study in detail the behavior of the two mated units in a seaway, time domain motion analyses were performed. Using Ultramarine's MOSES software, the barge and the rig hulls were modeled, see figure 5. The rig hull was built up with 1,020 panels and the barge hull with 705 panels. All internal ballast tanks were included in the barge model. Using cribbing (compression only) springs, the models were connected at four brace support points (each point representing 2 support brackets) and the two guideposts forward. Four soft mooring lines were added to the rig to keep the models in position. The barge was ballasted such that each corner carried 1,000 t. Using 3-D diffraction theory, the combined units were then subjected to a range of wave heights, periods, and directions to study the loads in the support points (both vertical and lateral) under these various conditions and to determine the limiting operation wave conditions for the offshore part of the tow.

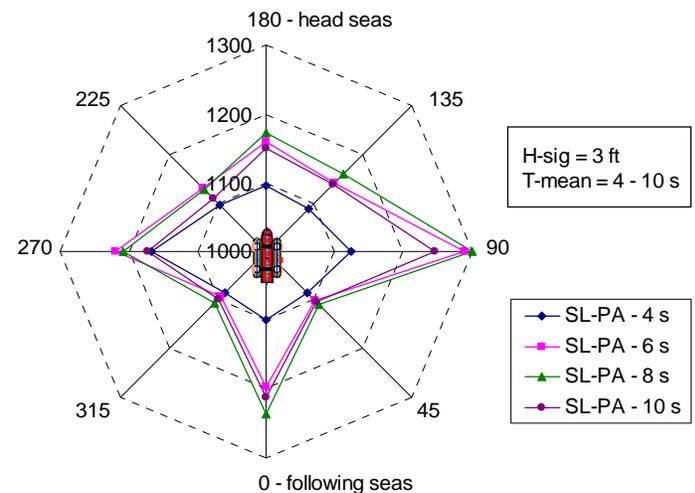
Figure 6. Support load (t) at the port aft point versus wave heading.

Given a .9 m (3 ft) significant wave height with a range of wave periods, the dynamic vertical support loads were calculated for all wave headings, see figure 6. In head and following seas, there is some pitch influence, while in beam seas the roll and heave components (which can be in or out of phase) dominate. The aft supports are more impacted by following seas, while the forward supports see higher loads in head seas. But beam seas dominate. Dividing the maximum support loads by the static support load (1,000 t per corner) gives dynamic load factors. For 8 s following seas, the dynamic load factor is found to be 1.25.

For the port aft support point, a dynamic load factor of 1.3 was found at 8 s beam seas coming in from the starboard side (heave and roll in phase). This same wave condition results in a dynamic load factor of 1.2 for the beam seas coming in from the port side, whereby heave and roll are out of phase. For the starboard aft support point, the reverse was found. At no time, gapping or uplift at any of the support points was found.

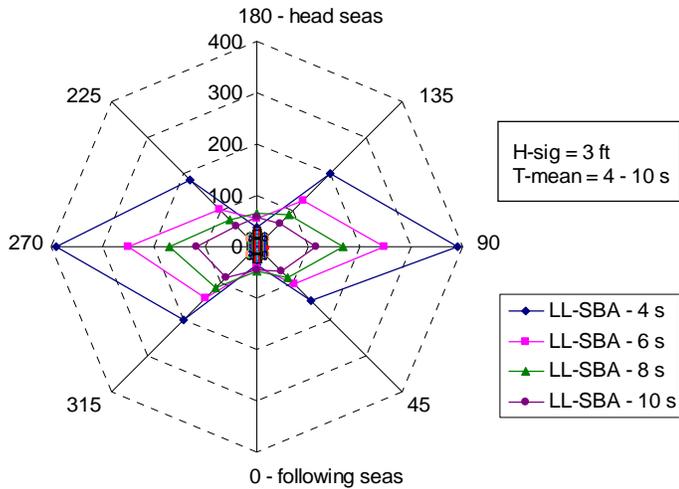
Figure 7. Lateral loads (t) at the starboard aft point versus wave heading.

Except for the 4 s beam seas case, the maximum lateral loads in way of the support blocks were found to be well within the 30+% friction resistance capability of steel on wood, eliminating the need for any lateral securings, see also figure 7.

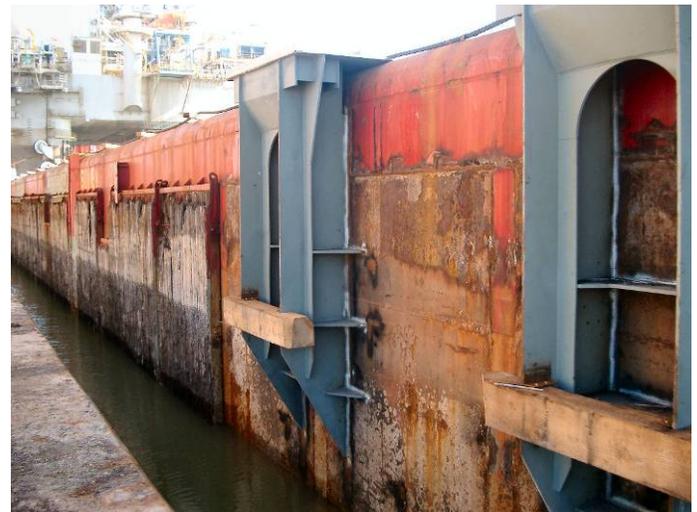
Figure 8. Support brackets welded to barge hull.

The cargo barge was surveyed to double check its suitability. Eight large support brackets, each weighing approximately 3,200 kg (7.0 kips) were prefabricated and welded to the sides of the barge, after local removal of some of the fendering, see figure 8. These support brackets provided the interface with the rig braces at the new diaphragm locations, and carried the lift loads directly into the side shell of the barge.

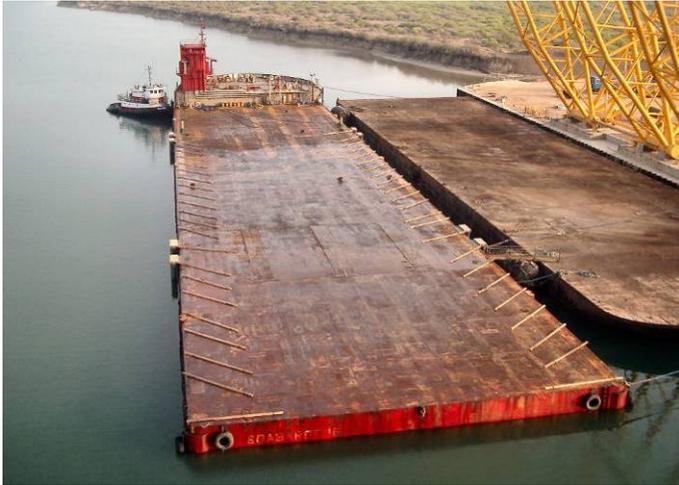
Figure 9. Wooden fenders on barge deck.

To avoid steel to steel contact during the barge removal offshore, a herring bone pattern of 4" by 4" softwooden beams was secured to the deck, on either side, aft of the guide posts, see figure 9.

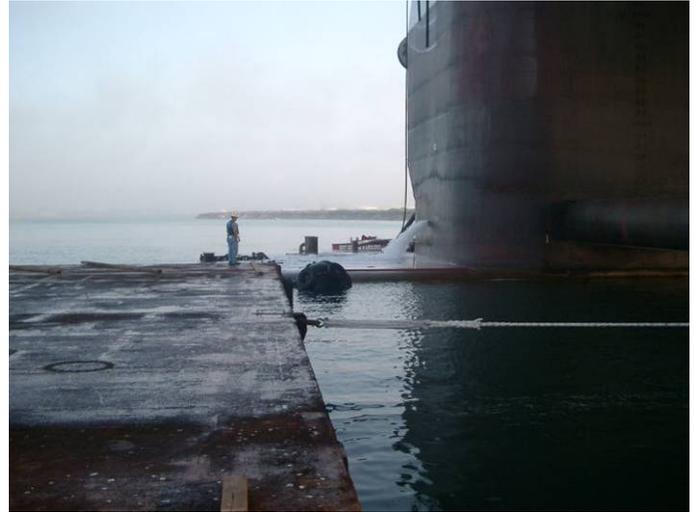
Figure 10. Barge pulled in between rig pontoons.

When the rig was ready to receive the barge, the barge was ballasted down to a .9 m (3 ft) freeboard and maneuvered towards the rig, using local harbor tugs. Once in line with the rig, a line from a large forklift waiting on the quay was connected to the barge stern and the barge was slowly pulled between the pontoons, under a watchful eye of the attending marine warranty surveyor, see figure 10. The assist tugs pushed and pulled to keep the barge hull away from the pontoons and the protruding drain pipes. When the guide posts made contact with the forward rig brace, the barge was held in position by keeping tension on its stern wire. Come-a-longs were hooked up at the four corners, to lock the barge in position and assist with the fine-tuning. Based on the positioning marks on the aft brace, the barge was exact in position. However, the CL mark of the barge was still 6 inches off from the CL mark on the forward rig brace, and both (longitudinal) guide posts were tight against the forward brace. To get the forward marks in line, the barge needed to be rotated, which seemed unlikely (the position of the guide posts had been checked and double checked before and after installation). It quickly became clear that the CL mark on the forward rig brace was off center... Using a tape measure, the correct rig CL location was marked on the brace and some small adjustments were made laterally until the barge centerline was exactly under the rig centerline, both fore and aft. The barge was then deballasted until the wooden cribbing blocks made contact with the rig braces. Upon re-confirmation of the positioning fore and aft, the cargo barge was deballasted until the rig draft was reduced by 1 meter (3.3 ft). Total duration from unmooring the ballasted barge to

completion of deballasting was 8 hours (3 hours for maneuvering and positioning, 5 hours for deballasting).

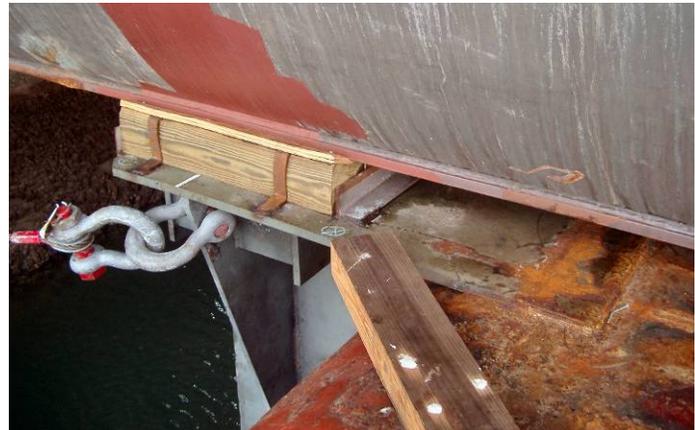
Figure 11. Port aft cribbing block compressed after lifting rig.

Because of the limited support area available, the cribbing blocks were loaded to a high static pressure of 42 kg/cm<sup>2</sup> (600 psi), close to the crushing limit of the yellow pine wood, see figure 11.

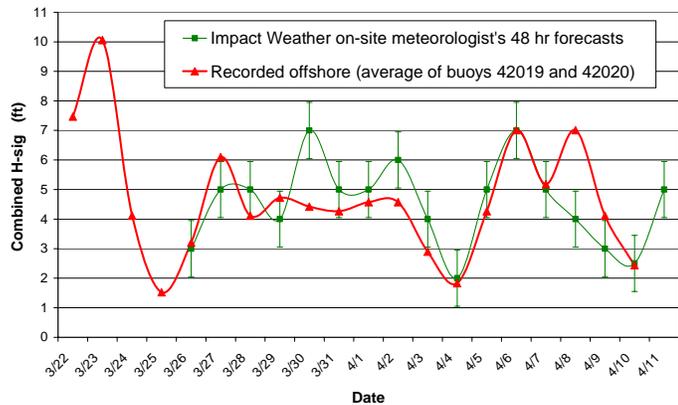
Figure 12. Comparison daily 48 hr wave forecasts with actual measured wave heights offshore Corpus Christi.

The tow-out and consequent barge removal operation were both weather sensitive, the first with respect to wind speeds and the latter with respect to wave height and period. Because of the size of the combined units, the channels were to be closed for all other shipping traffic by US Coast Guard, for which they and the Corpus Christi Port Users needed at least a 48 hours advanced notice. To have the best possible weather information available, an on-site meteorologist from Impact Weather was hired and set up at the yard. The 48 hour forecasts were compared to the actual wave conditions offshore, as measured by the NOAA buoys, see also figure 12. Early April, the tow-out window opened up when a fast passing cold front created a temporary northern wind which knocked down the high southerly swell, and with insufficient duration to build a new swell. The predicted tow-out wind speed of 14 knots was just within the 15 knots limit - unusual favorable conditions, giving that an annual Windfest festival was going on in a neighboring town. The 48 hour forecast was spot on, and the offshore waves died down as predicted, in spite of an unforeseen surge.

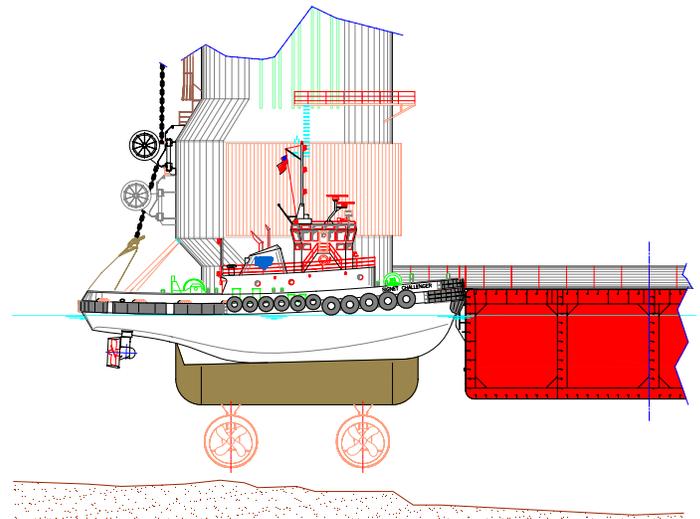
Figure 13. Signet Challenger pushing directly against barge hull.

restrictions for the assisting tugboats. The barge hull, with a freeboard of 2.2 m (7.2 ft), protruded both fore and aft past the rig pontoons, thus providing excellent push areas for the assisting harbor tugs, see figure 13. The anticipated maximum push and pull forces of the tugs were much less than the total friction restraint between the cribbing blocks and the rig braces.

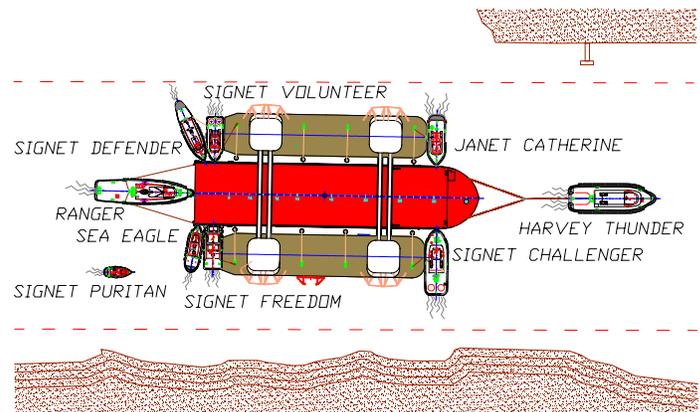
Figure 14. Tug configuration during tow-out through the 400 ft narrow La Quinta Channel.

The harbor tugs were used fore and aft in athwartships direction, more or less acting as transverse thrusters. The bigger oceangoing tugs were used to pull on the barge's tow bridle and push aft against the barge transom, see figures 14 and 16.

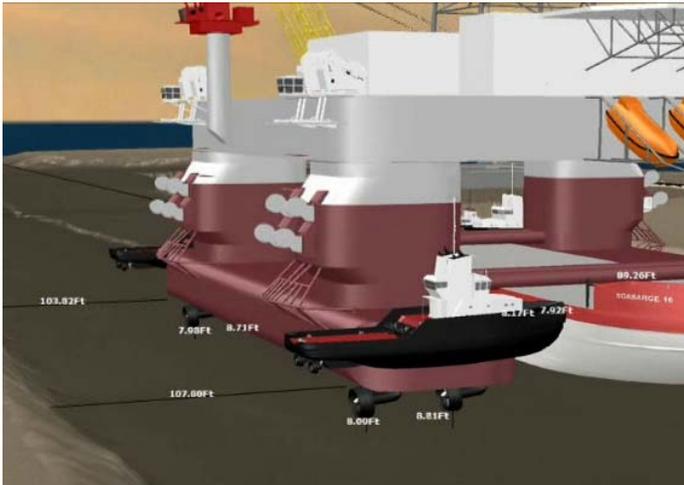
Figure 15. Geo Century 3-D display of thruster clearance with bottom and sides of channel.

An advanced Geo Century real-time Skyfix DGPS navigation system that incorporated 3-D imagery of the channel for the total passage was used to ensure that the rig stayed inside the safe canal boundaries at all times, day or night, see also figure 15. Continuous updates on the true distances between the rig thrusters and the channel bottom as well as sides were displayed in real time. Because of the size of the combined units, the US Coast Guard would normally have restricted this 12 hour voyage through the narrow channels to daylight hours only. However the proposed use of the 3-D imagery provided a high level of confidence that the tow-out could be executed safely, even during darkness. A central navigation visualization and control unit was installed on the navigation bridge of the rig, and hooked up to the various input sensors. Auxiliary slave display systems were installed on several of the assist tugs. All auxiliary units were in contact with the main control unit, using real time telemetry. Because the tug captains could monitor where the rig was and where it was heading at any time, they could take immediate action to minimize any deviation from the intended path and to control its movements, oftentimes before being requested to do so by the towmaster or pilots.

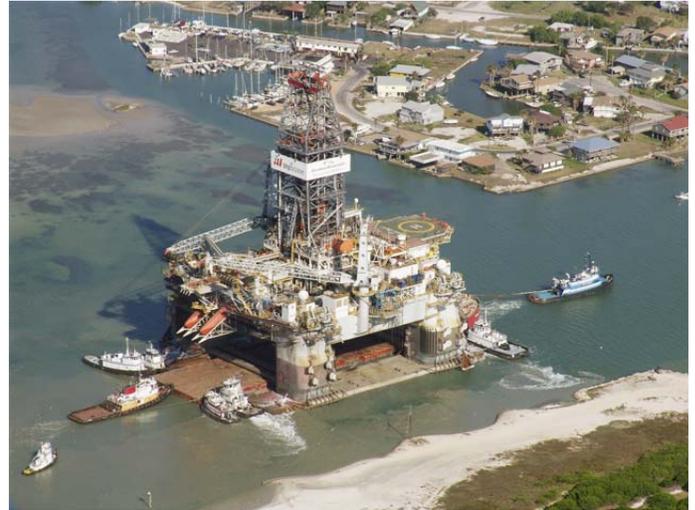
Figure 16. Tow in La Quinta Channel, passing Ingleside on the Bay.

mooring lines cast off. Using the assist tugs, the rig and barge combination was successfully maneuvered away from the deep hole at the dock, rotated 90 degrees and moved to the center of the very narrow La Quinta Channel, see also figure 16. During this first maneuver, a short blast with the starboard outboard thruster was given to check the response of the rig with barge.

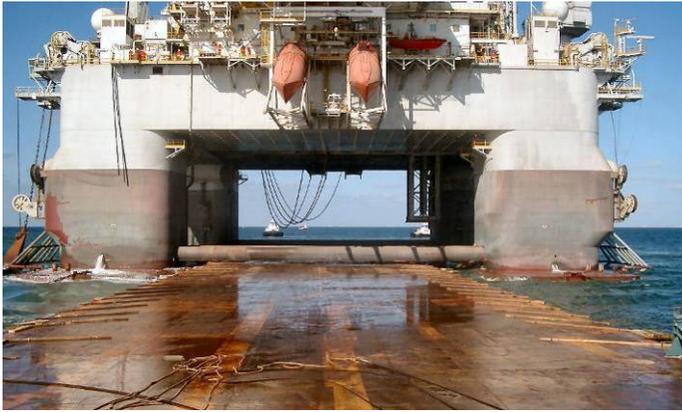
Figure 17. Barge pulled out from under rig braces.

Starting at 6:45, the cargo barge was ballasted down according to the planned sequence. First the rig was lowered level back to its own unsupported draft. Then the barge stern was ballasted to create a gap with the aft braces. Continuing ballasting the barge down also freed the bow supports and the barge started to become lively, heaving and pitching in the

waves. At this time (9:40), the two mooring lines were released and the barge was quickly pulled out from between the rig pontoons, lightly bumping the rig braces with its deck fender blocks only once on the way out. The rig's DP thrusters were used to rotate the rig about 2 degrees to starboard when the barge started to shift during the move out, thereby eliminating any lateral barge to pontoon contact entirely. The challenging tow-out was successfully completed, see figure 17.
